IN THE UNITED STATES DISTRICT COURT
FOR THE SOUTHERN DISTRICT OF TEXAS
HOUSTON DIVISION

PLAINTIFF'S ORIGINAL COMPLAINT

14. The 52.5-ton grinder that mutilated Mr. Castañeda's arm was a 2014 Diamond Z horizontal grinder, Model No. DZH6000TKT-3, VIN 1R9FX6707EC722003 (herein the "Diamond Z grinder"). This grinder was purchased second-hand on December 12, 2014, by Plaintiff's employer, Precision Land Clearing, Inc., a Texas corporation. For the purpose of this pleading, the side of the grinder on which Mr. Castañeda was located when his arm became entrapped will be referred to as the "curbside", as Mr. Castañeda was on the opposite side of the grinder from the side shown below.

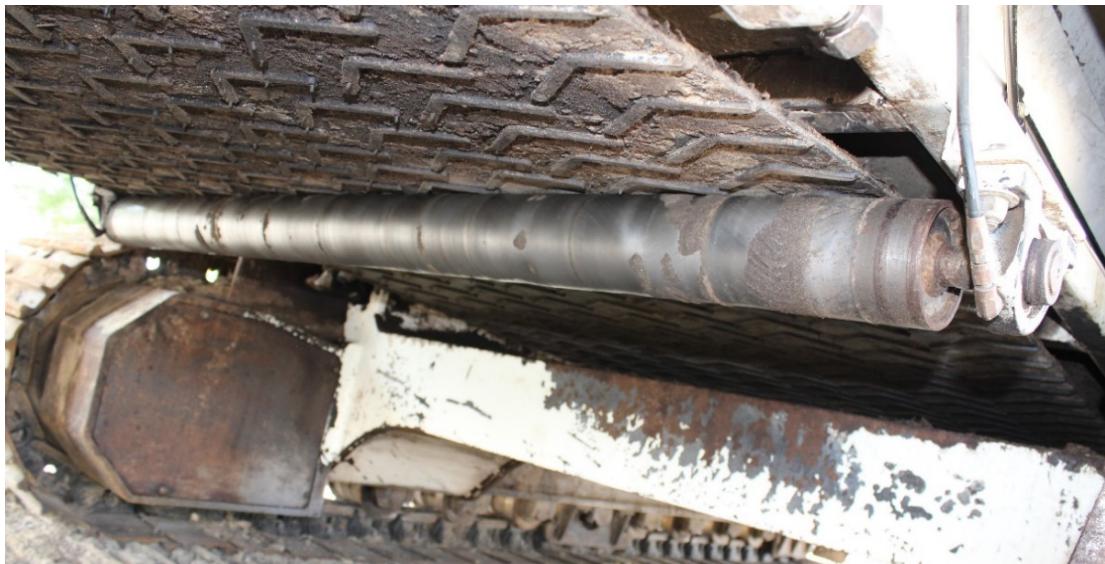
17. After the product is crushed, it falls onto the "Phase I" conveyor belt (pictured below) which runs horizontally underneath the grinder's body and carries the crushed product to the "outfeed" conveyor belt.
